AMMRC TR 85-16

DEVELOPMENT OF A NITRIDE DISPERSION STRENGTHENED (NDS)
METALLIC ALLOY FOR HIGH-TEMPERATURE RECUPERATORS

June 1985

L. E. KINDLIMANN
AiResearch Manufacturing Company
2525 W. 190th Street
Torrance, California 90509

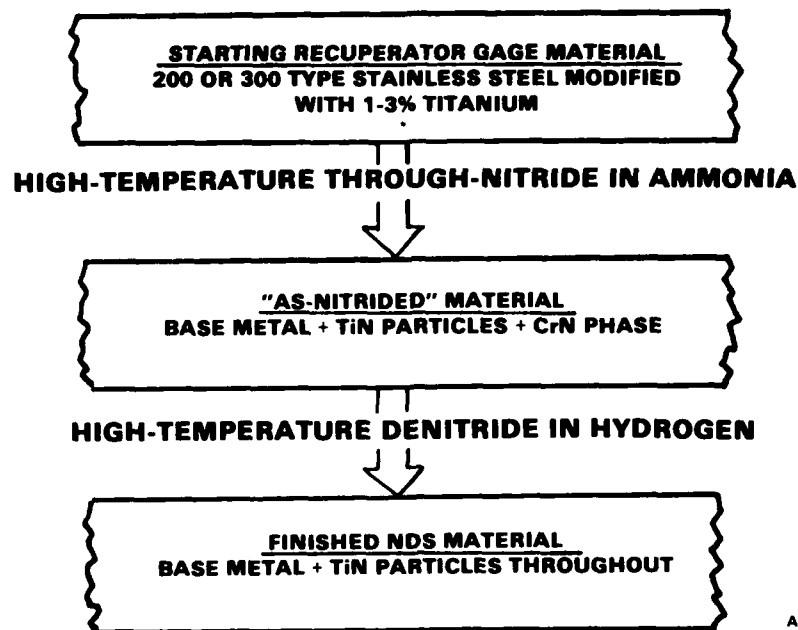
Figure 2-1. Schematic of Nitride Strengthening Process

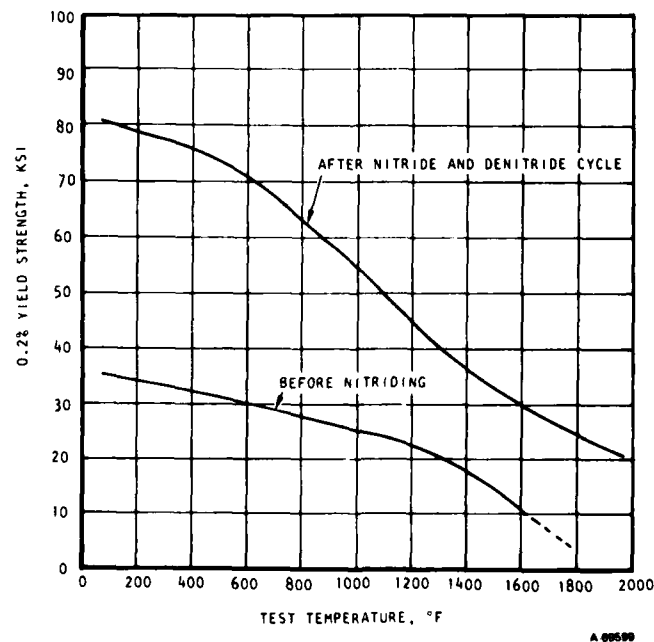
Figure 2-2. Yield Strength Improvement as a Result of Nitriding an 18Cr-12Ni-2Ti (Modified Type 321) Stainless Steel (Reference 2)

Applying the high-temperature nitriding treatment to a stainless steel of composition that is nominally 18Cr-12Ni-2Ti-Balance Fe (a low-carbon, high-titanium modification of Type 321 stainless steel) results in improved mechanical strength, as shown in Figure 2-2. Creep properties are shown in Figure 2-3, where the Larson-Miller master curve technique is used to compare commercial sheet alloys with projections for the NDS alloy taken from References 3 and 4 and from preliminary testing prior to the inception of this program. Curves for other materials were plotted from vendor and literature data. For prolonged service above 1500°F, the NDS alloys have significantly higher projected creep strength, with the margin becoming even greater as the time-temperature parameter increases.

Data used to generate the curves given for NDS alloys in Figures 2-2 and 2-3 were obtained primarily from laboratory-sized samples that were produced individually. Creep data above 1500°F were from fairly short time tests (typically, several hundred hours) or were estimated from rupture test results. There are a number of major prerequisites to the successful implementation of an NDS alloy to the production of a new high-operating-temperature recuperator. These prerequisites form the basis for the work on the individual tasks shown in Figure 2-4 and described below.

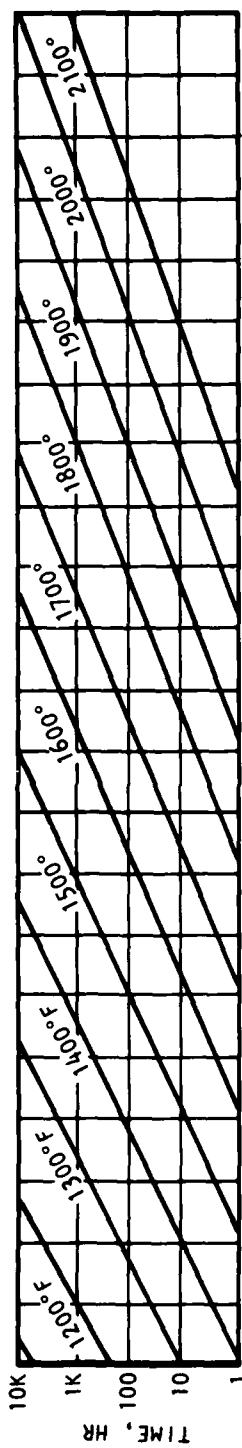
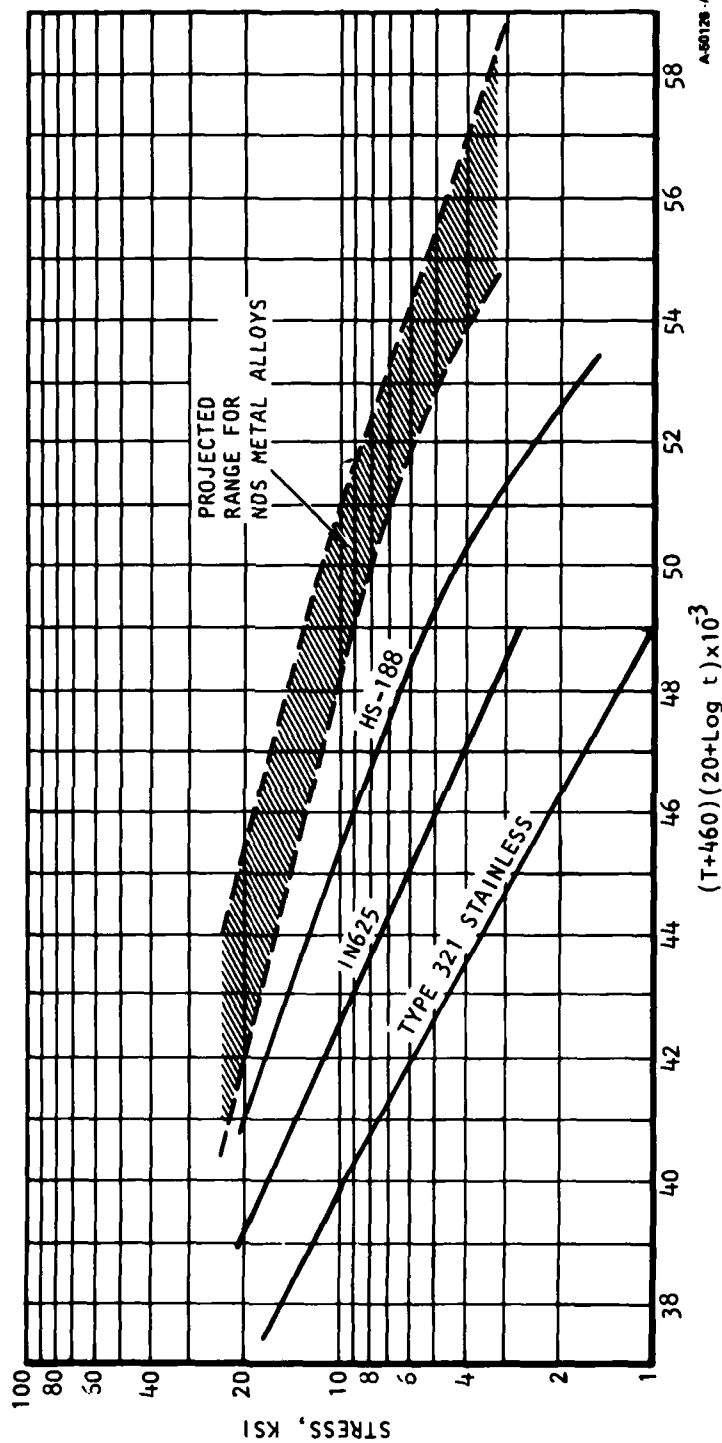
Figure 2-3. Master Plot Comparing Projected 1-Percent Creep Behavior of NDS Alloys to Commercial Sheet Candidate Recuperator Materials

Although markedly superior to the Inconels in creep strength, NDS 300 failed to meet the projected minimum curve of Figure 2-3 in longer-time, lower-stress tests above 1700°F, especially when braze coated. From microstructural analysis, this appeared to be caused by insufficient nitriding with the partial treatment cycle. Accordingly, several tests were conducted near the end of the program using modifications of the previously described B and C treatments. High elongation of A material rupture tested at 1800°F suggested a much higher creep rate, possibly due to the fine grain size. Microstructures of the material produced with a modified B treatments are compared to A-treated material in Figure 2-11. The structures shown for runs 286, 287, and 288 correspond to material given a B treatment and show a coarser grain size near the surface than occurs with A material heated in ammonia. The darker areas near the center are indicative of a coarser TiN dispersoid which will be less effective in strengthening. Note that this characteristic essentially

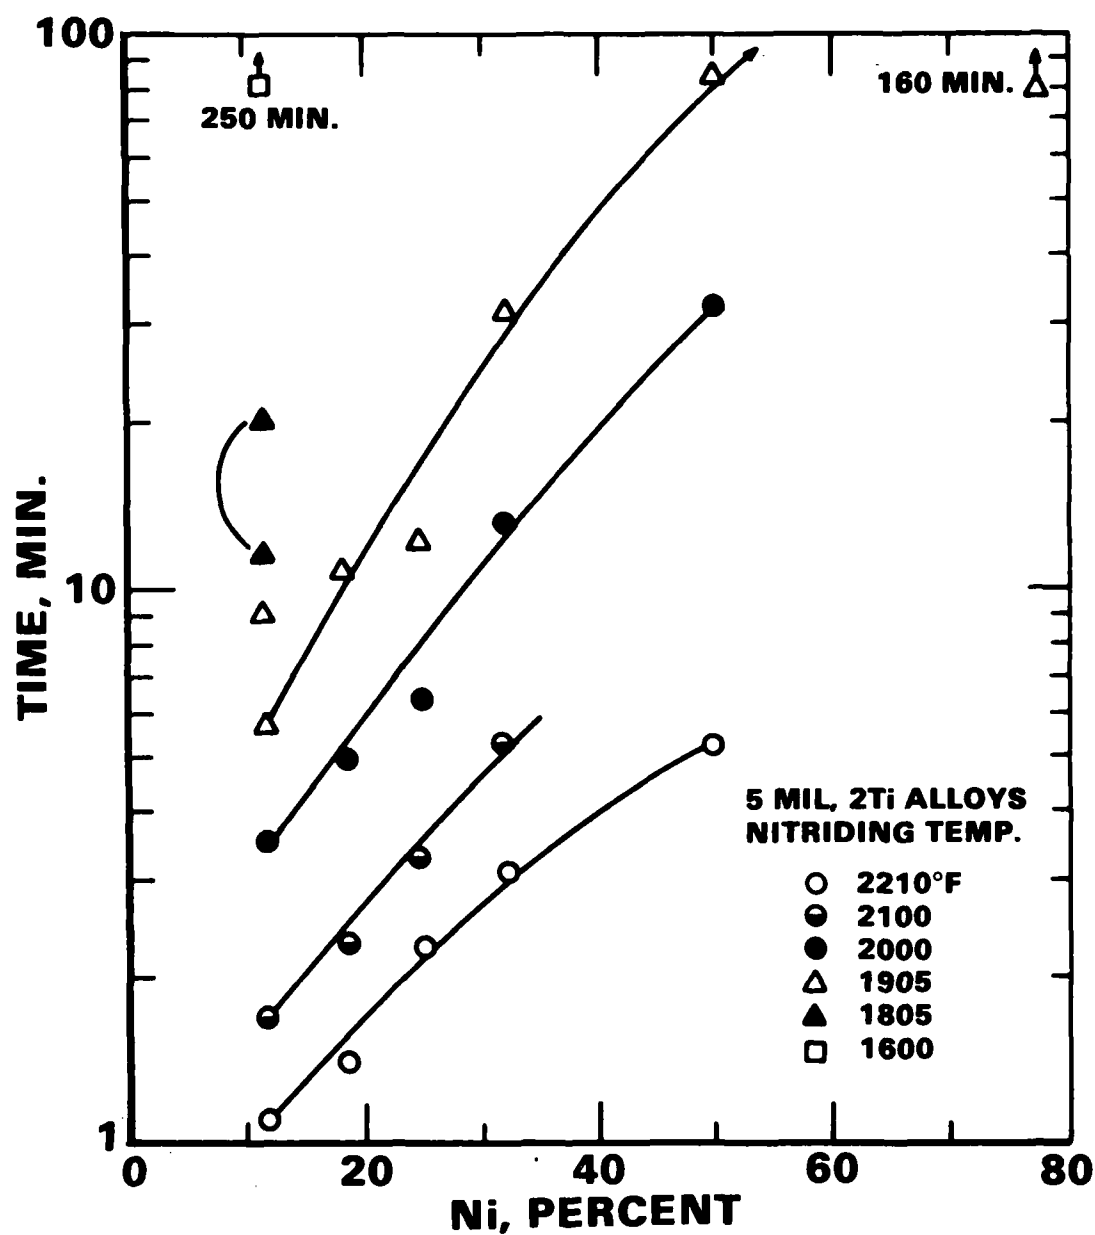
Figure 2-5. Minimum Time to Through-Nitride 5-Mil (0.005-in.) Thick Material Versus Nickel Content (Alloys Contain 18-20Cr and 2Ti, Balance Fe)

Times shown in Figure 2-5 would be typical for recuperator fin material. For plate material (sized 0.010-in.-thick for strength and fabricability), the times in Figure 2-5 must be increased. For example, it had been found previously that to ensure complete nitriding of the titanium-modified 18Cr-12Ni stainless steel described earlier, 30 minutes is required for treatment of 0.010-in. material at 1900°F. Unfortunately, this is a fairly long time for a continuous line process; however, the excellent properties noted in Figure 2-3 were derived from material nitrided at about 1900°F.

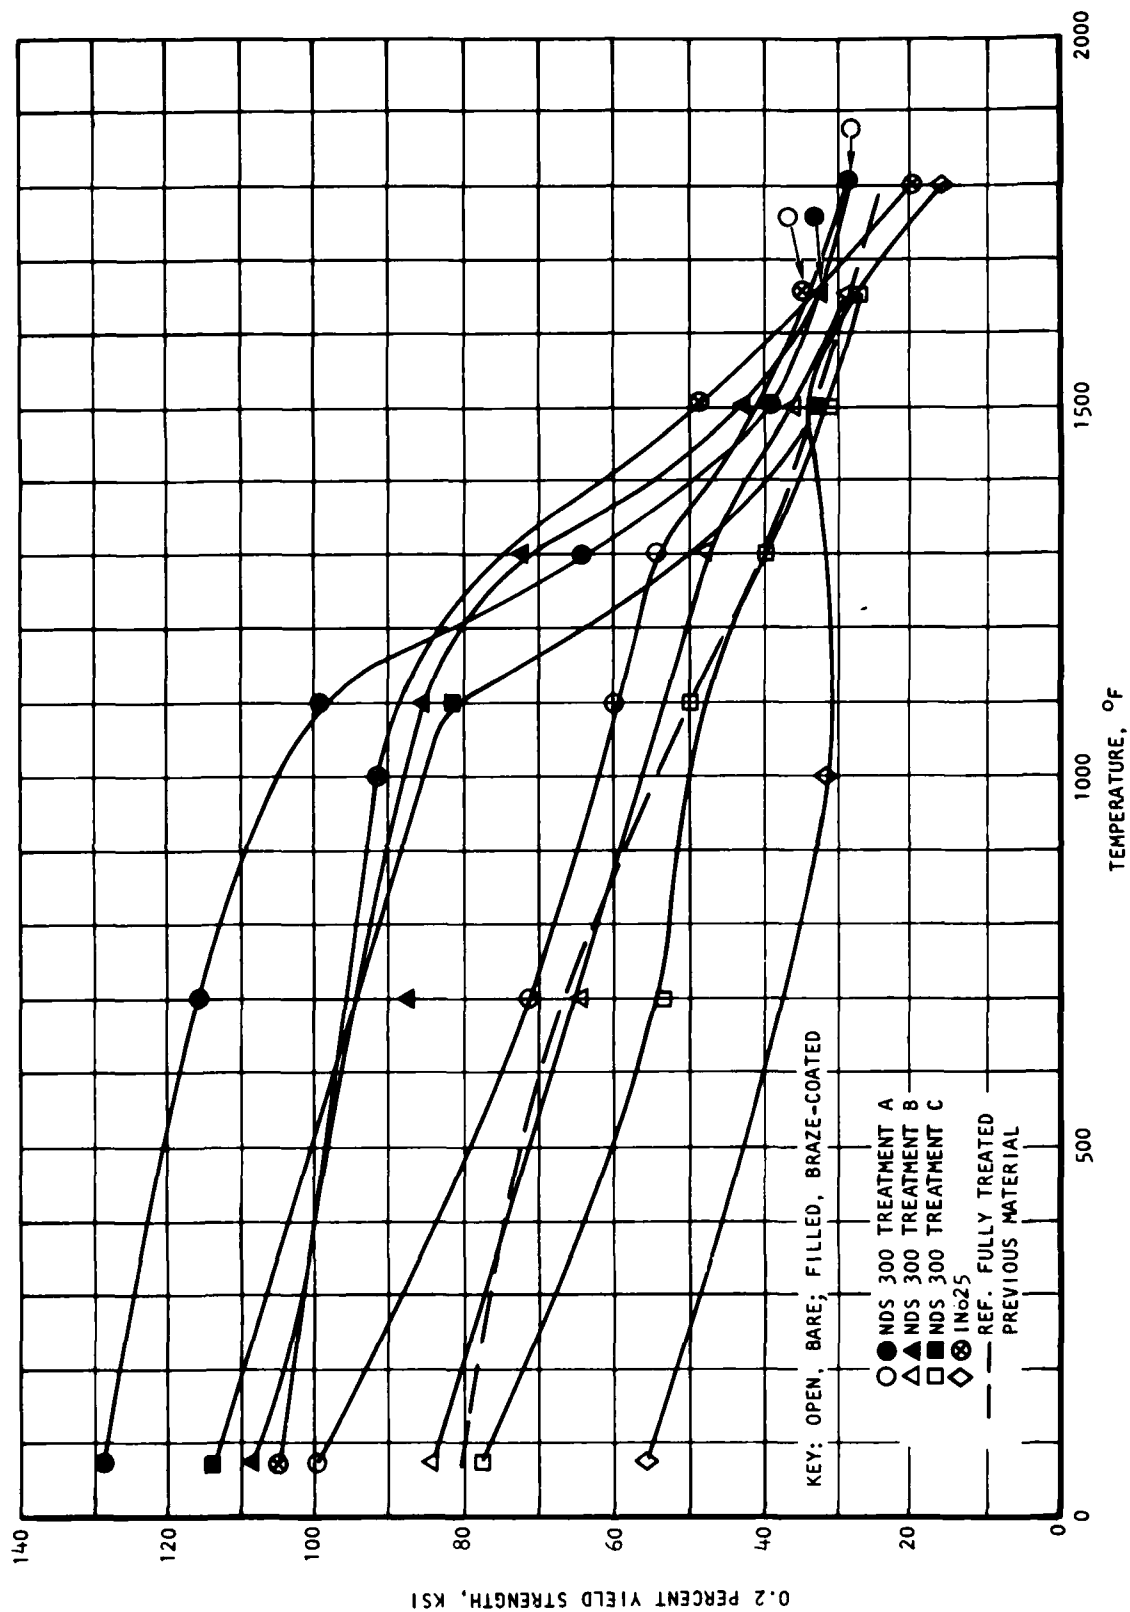
Figure 2-7. Yield Strength of Bare and Braze-Coated NDS 300 and IN625 as a Function of Temperature

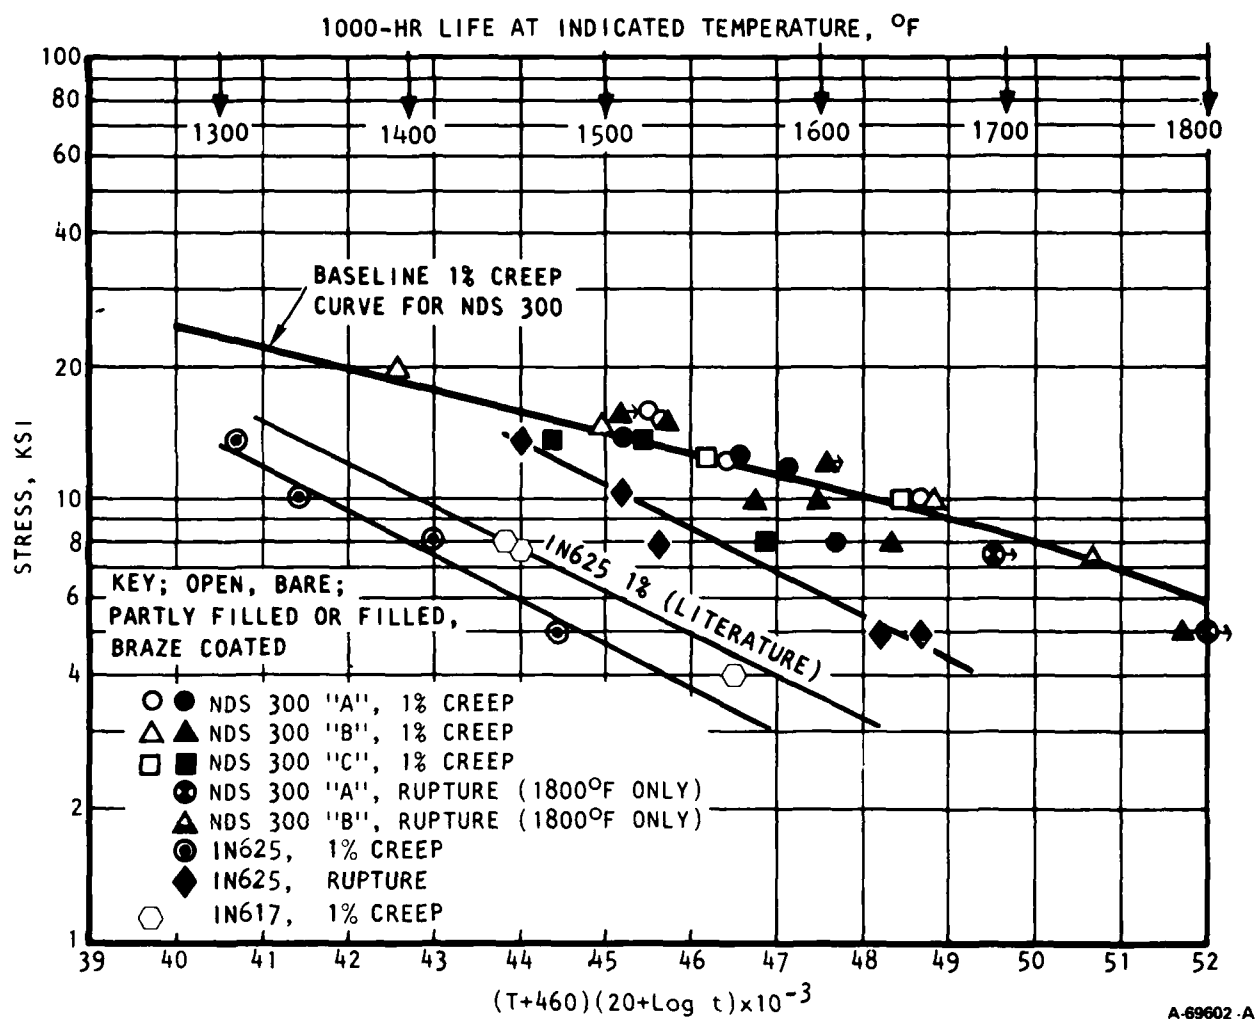
Figure 2-8. Comparison of Creep/Rupture of NDS 300 and Inconels 617 and 625

Creep test results on NDS 300 for the three treatments are given in Table 2-7. Minimum values for each test condition, bare and braze-coated, are plotted in Figure 2-8 for 1-percent creep extension (designated 1800°F points are rupture only for braze-coated material). Inconel 625 and 617 data from Tables 2-5 and 2-6 are also plotted in Figure 2-8. Again the A and B treated materials are strongest. The 1 percent creep points for braze-coated IN625 (plotted in Figure 2-8) are close to the literature curve, and are significantly higher than the braze-cycled bare material (Table 2-6); the braze-coated material is also stronger in rupture. The NDS 300 material is about three times as strong as IN625 in creep strength in the range of interest for recuperators, i.e., in the Larson-Miller parameter range of 45 to 47.5 (1000 hr at 1500° to 1600°F) where stresses are highest. This strength advantage for NDS 300 is apparently operative for even the weaker C material.

IN617 is stronger than IN625 in creep strength (as can be seen by comparison of Tables 2-5 and 2-6, and as shown in Figure 2-8), but it too has markedly lower strength than NDS 300. The Inconel alloys have been observed to stretch readily at these temperatures, even under low stresses. Creep strength is very low, and, while rupture strength is better, metallographic analysis has indicated that substantial intergranular oxidation is occurring (see Figure 2-9), with attendant loss in ductility at intermediate temperatures. Under the high stresses being used to test NDS 300, the lives of these Inconels have been short (compare Tables 2-5, 2-6, and 2-7). As a further illustration, creep curves for NDS 300 and IN625 are compared in Figure 2-10. While the Inconels show very high rupture ductility, extensive creep is generally unacceptable, i.e., design stress levels will have to be held very low by comparison to those allowable with NDS 300.

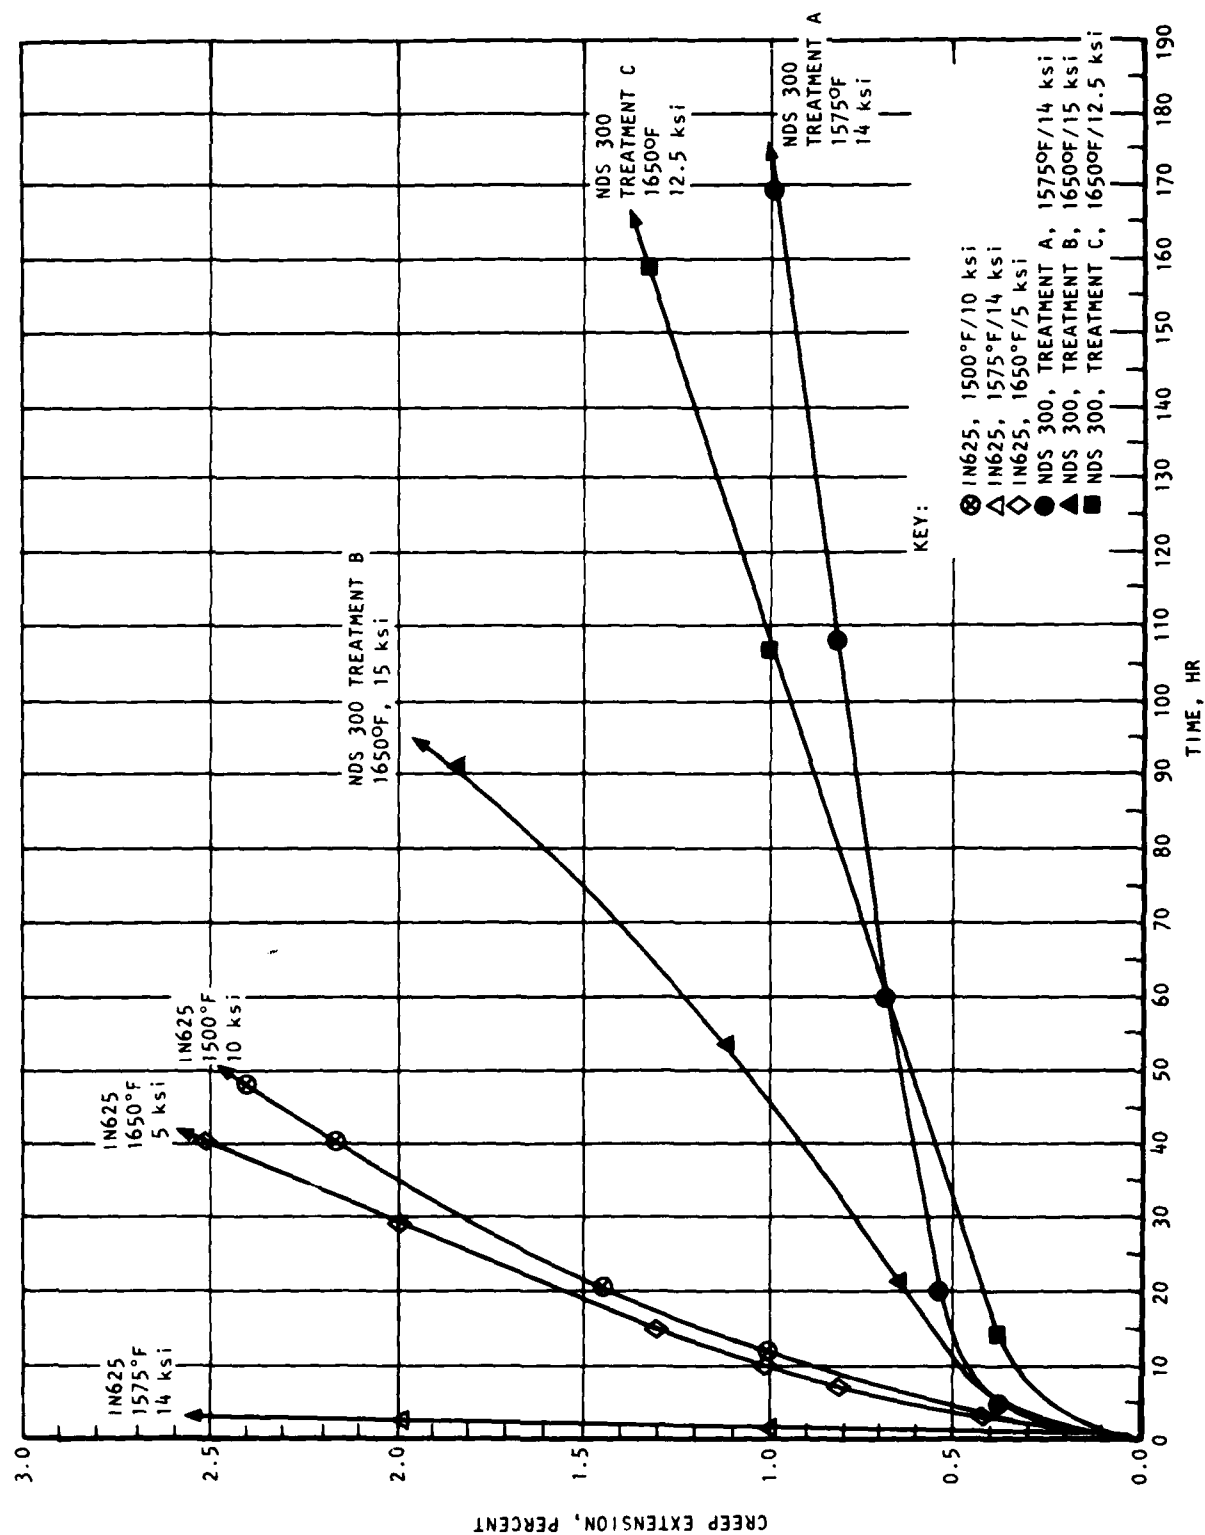
Figure 2-10. Comparison of Creep Curves for Braze-Coated NDS 300 and IN625

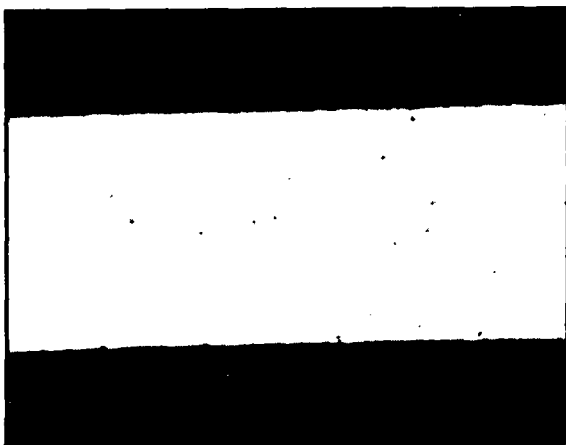
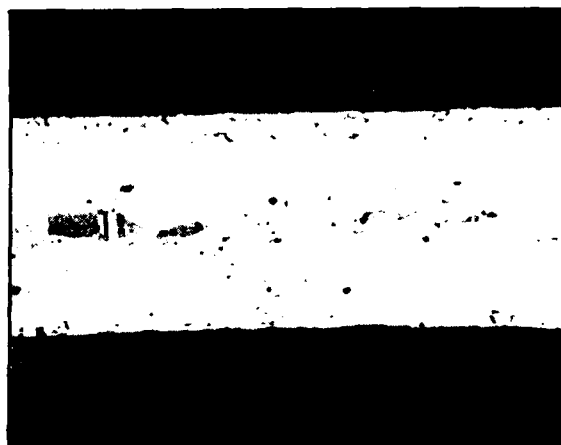
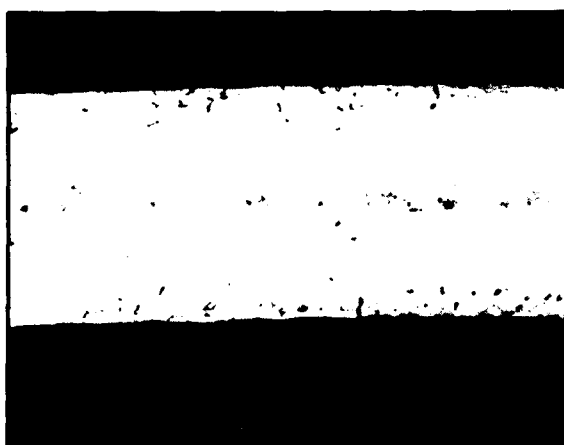
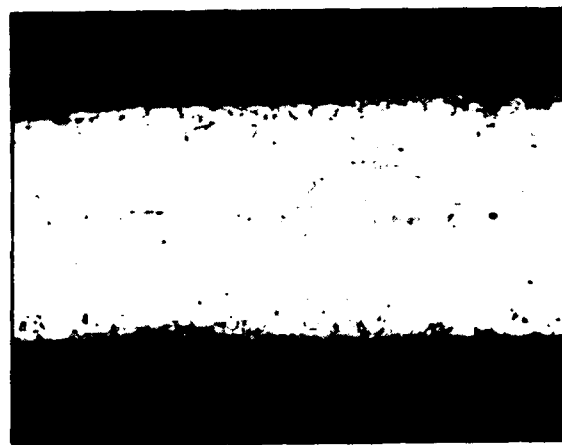
a. CONDITION A MATERIAL

b. RUN 286

c. RUN 287

d. RUN 288

Figure 2-11. Comparison of Modified Nitride Treatment B Microstructures to the A Treatment Structure; All B Samples Were Taken from Broken Tensile Test Specimens of Table 2-8 (Magnification, 200X)

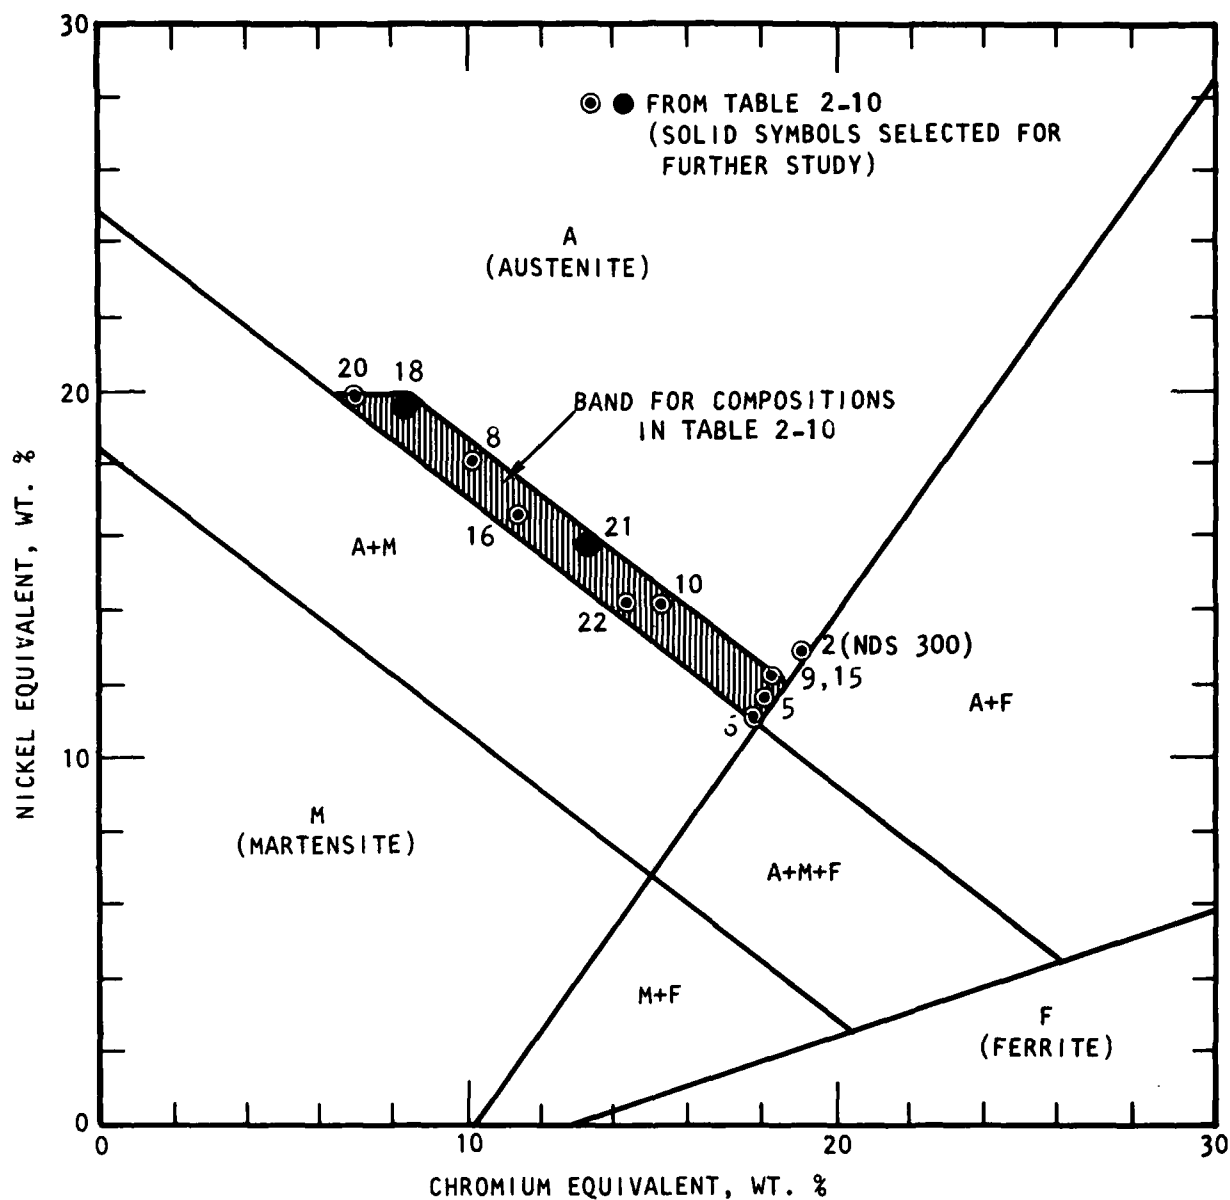
$$\text{Ni EQUIVALENT} = \% \text{Ni} + \% \text{Co} + 30(\% \text{C}) + 25(\% \text{N}) + 0.3(\% \text{Cu}) + 0.5(\% \text{Mn})$$

$$\text{Cr EQUIVALENT} = \% \text{Cr} + 2(\% \text{Si}) + 1.5(\% \text{Mo}) + 5.5(\% \text{Al}) + 1.5(\% \text{Ti})$$

Figure 2-12. Modified Schaeffler Diagram for Austenite-Martensite-Ferrite Phase Balance in Austenitic Stainless Steel Weldments (Reference 5)

In modifying the base chemistry for increased nitriding rate, the austenitic structure must be maintained if high-temperature strength is to be retained. There have been many treatises on the effects of composition on phase balance in stainless steels. One of the most recent is by INCO (Reference 5) which deals with replacement of chromium in stainless steels. Simply put, the three possible room-temperature phases--austenite, ferrite, and martensite--can be mapped by compositional balance, as shown in Figure 2-12. The important points to recognize are (1) the need to increase nickel equivalent (by manganese addition) as chromium level is decreased in order to stay within the austenitic field, and (2) the need to stay along the left-hand side of the austenite field so that the nominal 2Ti addition does not push the starting raw material into the two-phase austenite plus ferrite region to the right side of Figure 2-12. (Once the TiN dispersoid is formed, the titanium content of the alloy is ignored in calculating the chromium equivalent per Figure 2-12.) The objective was to achieve an increase in nitriding rate by adding manganese for increased nitrogen solubility (Reference 1) without upsetting the austenite phase balance. Conversely, elements other than titanium which also form nitrides should be decreased to help achieve a faster nitriding rate. For example, additions of aluminum, vanadium, and columbium would be undesirable, because these elements form nitride particles, which slow the overall nitriding rate without providing the degree of strength improvement obtainable with titanium nitride particles alone. Silicon and chromium have a similar effect, but to a lesser degree.

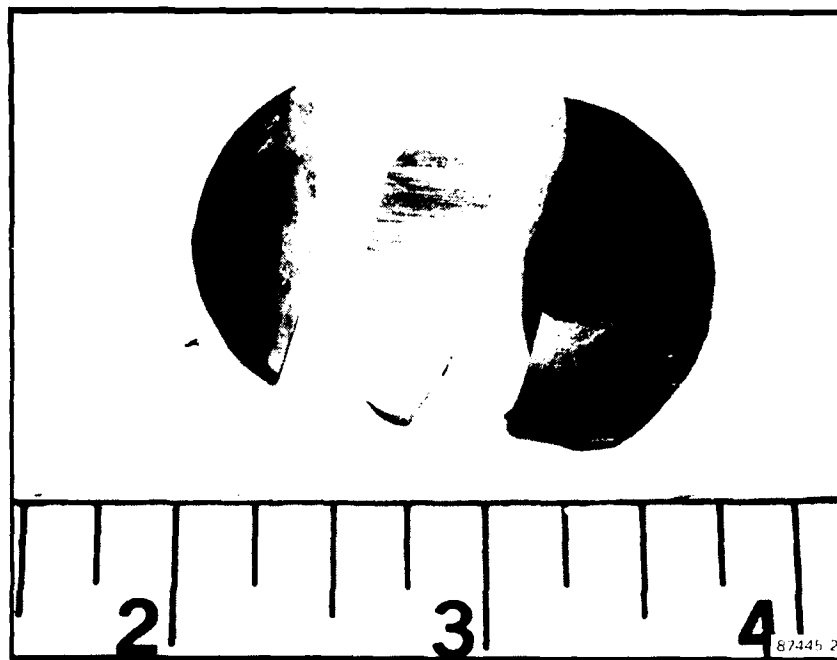
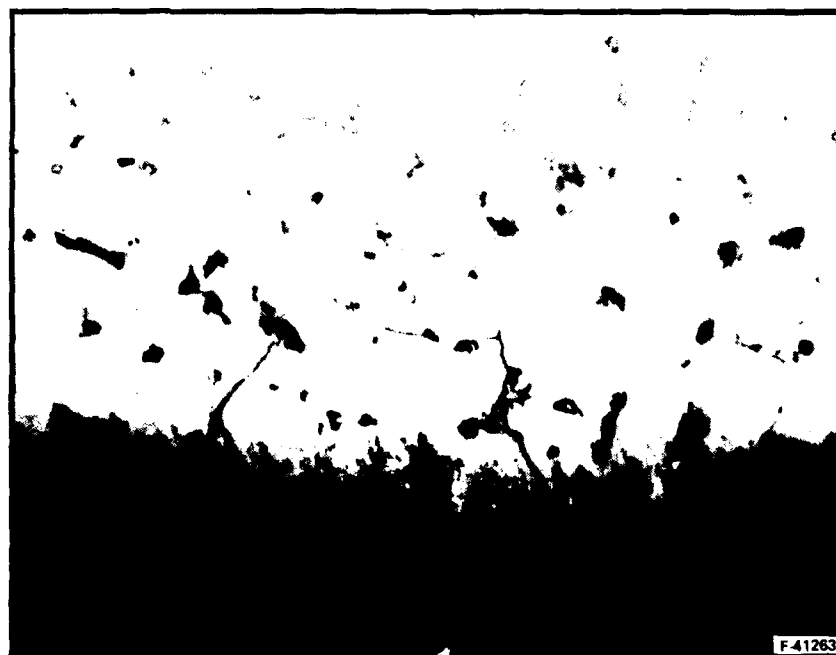
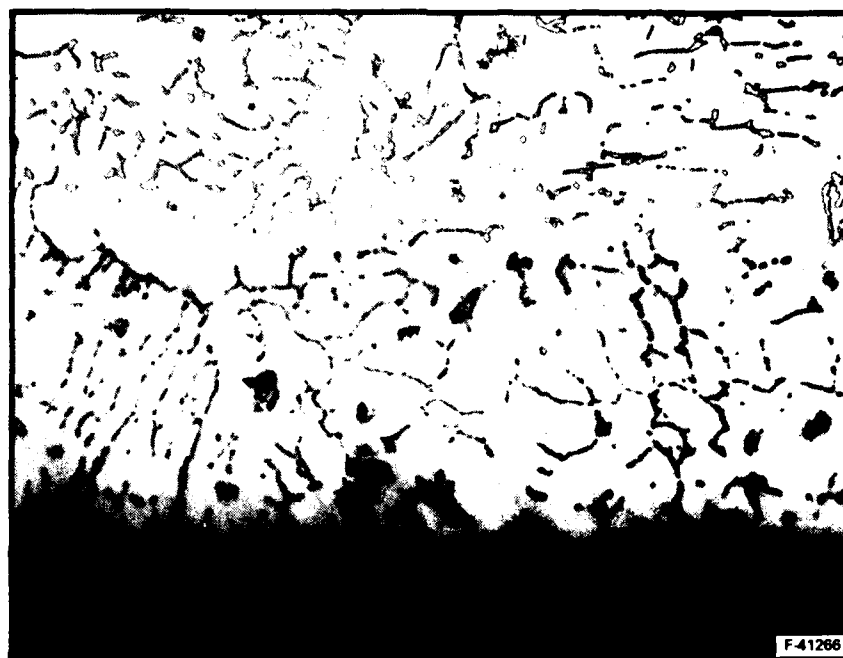
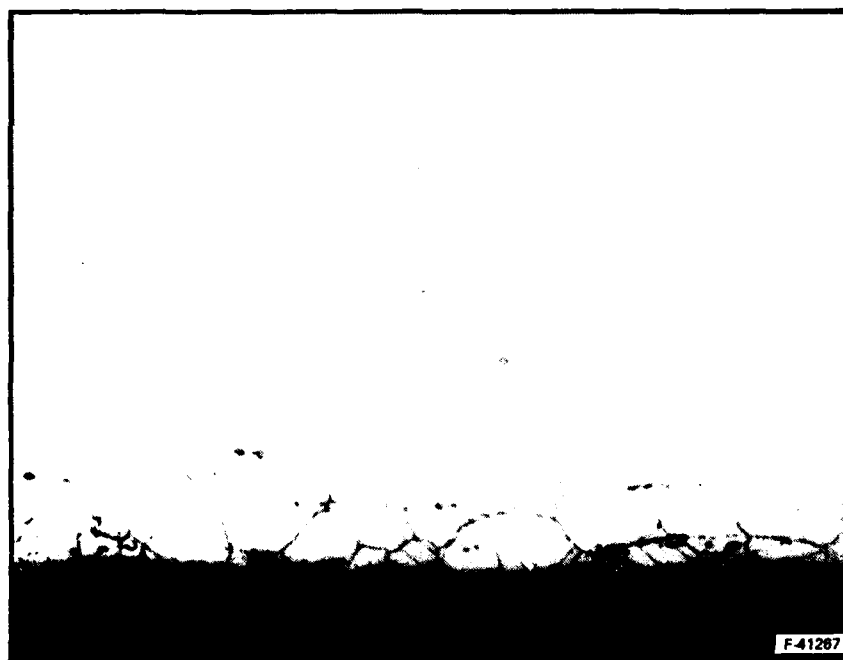
a. "INGOT" SLICED FOR NITRIDING AND CHEMISTRY

b. COMPOSITION NO. 18 FROM TABLE 2 10

Figure 2-13. Thirty-Gram Ingot and Comparison of Nitrided Structures of Two NDS 200 Compositions Selected to NDS 300 Strip (Magnification, 250X)

c. COMPOSITION NO. 21 FROM TABLE 2-10

d. NDS 300 STRIP (CONTROL)

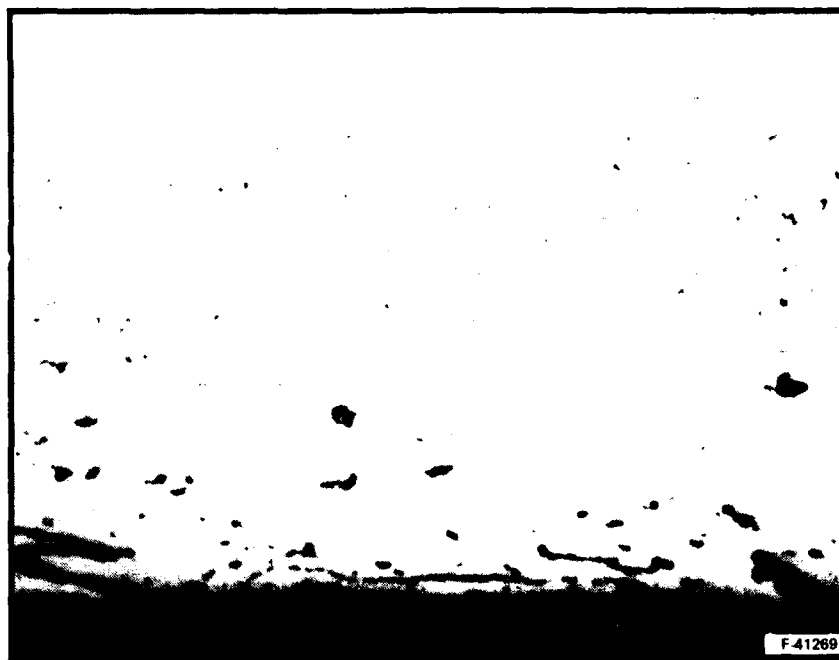
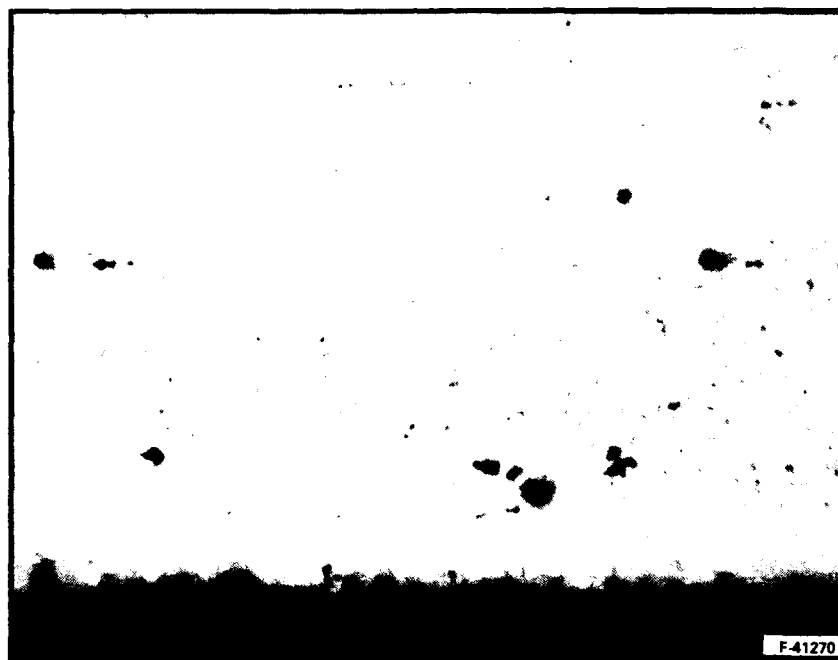
a. 12-PERCENT ELONGATION

b. 22-PERCENT ELONGATION

Figure 2-14. Microstructures of NDS 200 (Heat RV-9307) Versus Tensile Ductility (Magnification, 250X)

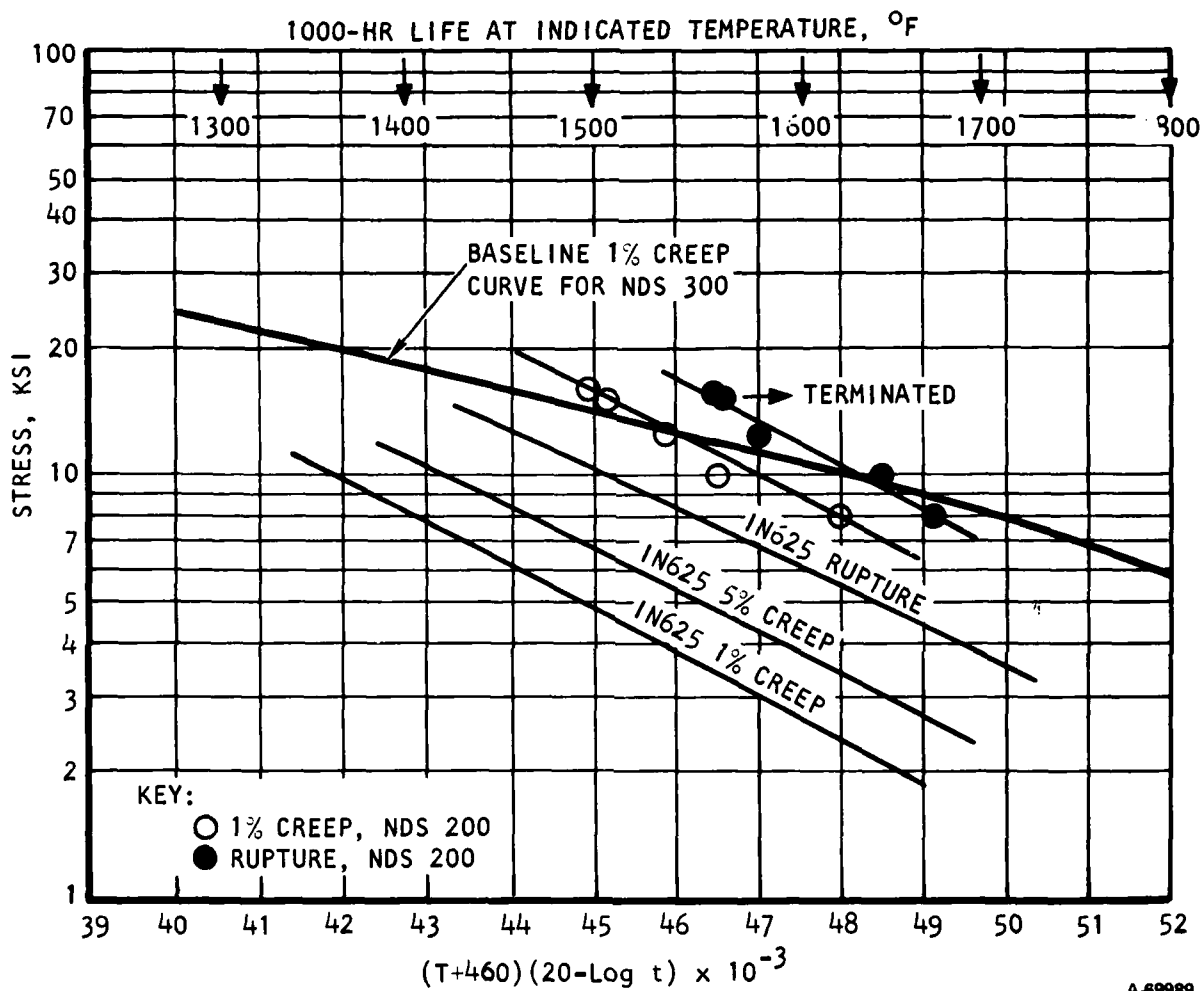
Figure 2-15. Comparison of NDS 200 to IN625 in Creep/Rupture Testing of Braze-Coated Material (IN625 Data from Table 2-5 and Figure 2-8)

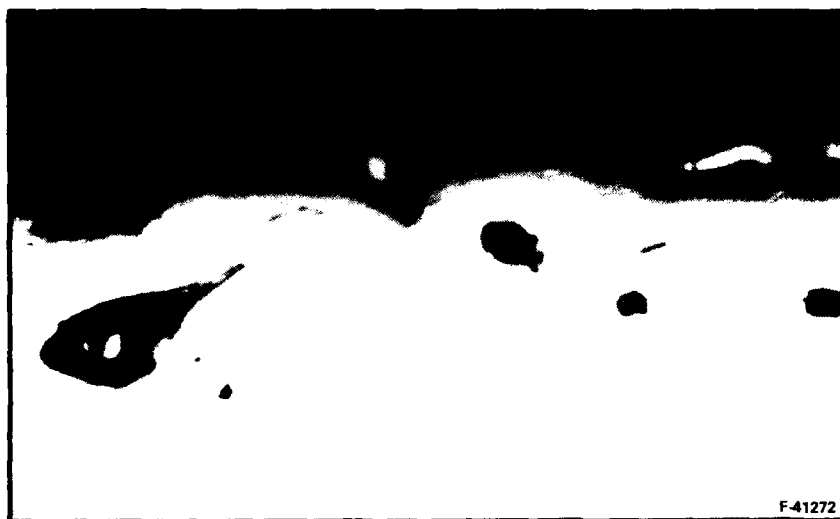
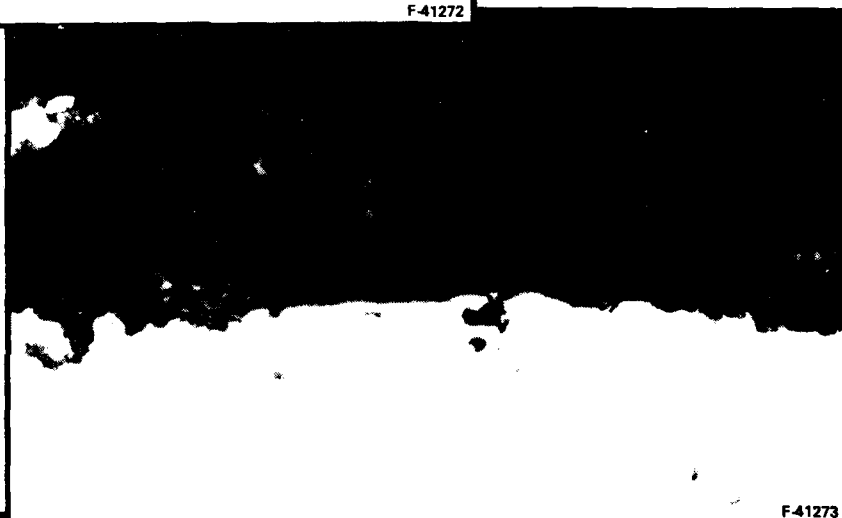
a. FILLER ALLOY 100B
AFTER 400 HR
AT 1800°F

b. FILLER ALLOY 100
AFTER 400 HR
AT 1800°F

c. FILLER ALLOY 100
AFTER 1023 HR
AT 1800°F

Figure 2-16. Cross Sections of Braze-Coated Cyclic Oxidation Test Specimens (Magnification, 250X)

d. FILLER ALLOY 100
AFTER 1023 HR
AT 1600 °F

e. NDS 300 CONTROL
AFTER 1023 HR
AT 1600 °F

f. NDS 300 CONTROL
AFTER 1023 HR
AT 1800 °F

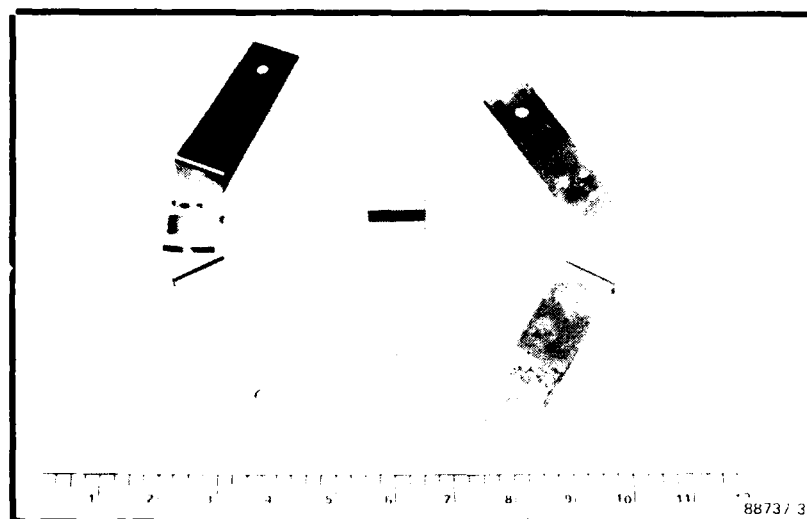
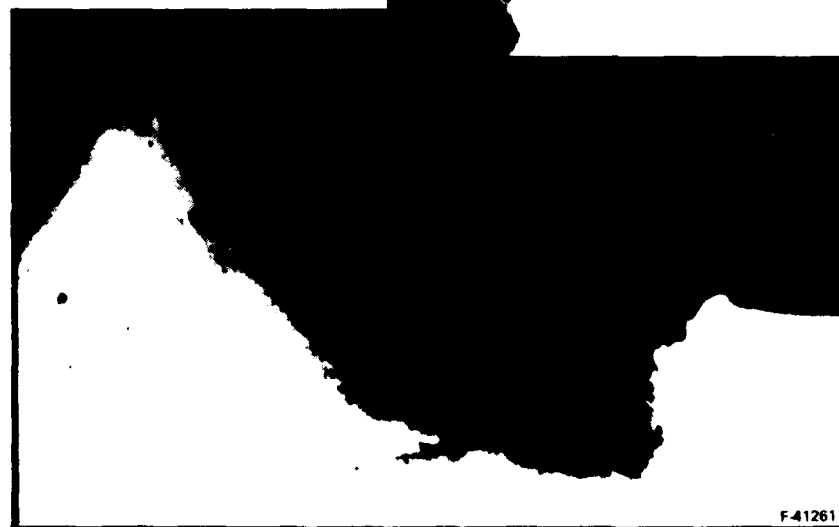
a. PEEL TEST SPECIMENS
(LEFT, READY FOR ASSEMBLY;
CENTER, ASSEMBLED WITH
2-MIL SHIMS;
RIGHT, BRAZED WITH ALLOY 100
AND TESTED)

b. FAILURE IN
PARENT METAL
(ALLOY 100 FILLER)

c. PRIMARY FAILURE IN JOINT
(ALLOY 915E FILLER)

Figure 2-17. Braze Peel Test Specimen and Modes of
Failure--1800°F Test (Magnification, 75X)

A few high-temperature braze peel tests were therefore conducted at 1800°F, as illustrated in Figure 2-17; data are summarized in Table 2-22. For the first round of tests shown at the top of Table 2-22, the boron-strengthened alloys such as 915 and 915E tended to break partly in the braze joints in this test, whereas boron-free alloys 100 and 100B broke in the parent metal at the braze fillet toe (see Figure 2-17 b and c). The second test series (lower half of Table 2-22) was designed to improve brazing flow by mixing in a small amount of a boron-containing filler metal at a level low enough to minimize the parent metal embrittlement effects noted earlier with the DF-4A/4B mix, and to avoid broken braze joints such as seen in Figure 2-17c. This set of samples was fabricated by different personnel, and the sensitivity of the test to preparation technique was evident in the reduced levels of breaking stresses. Although all failures were in the parent metal, apparently there were significantly higher bending moments in this second set due to a slight misalignment of the two sides of the peel test specimen. This does, however,

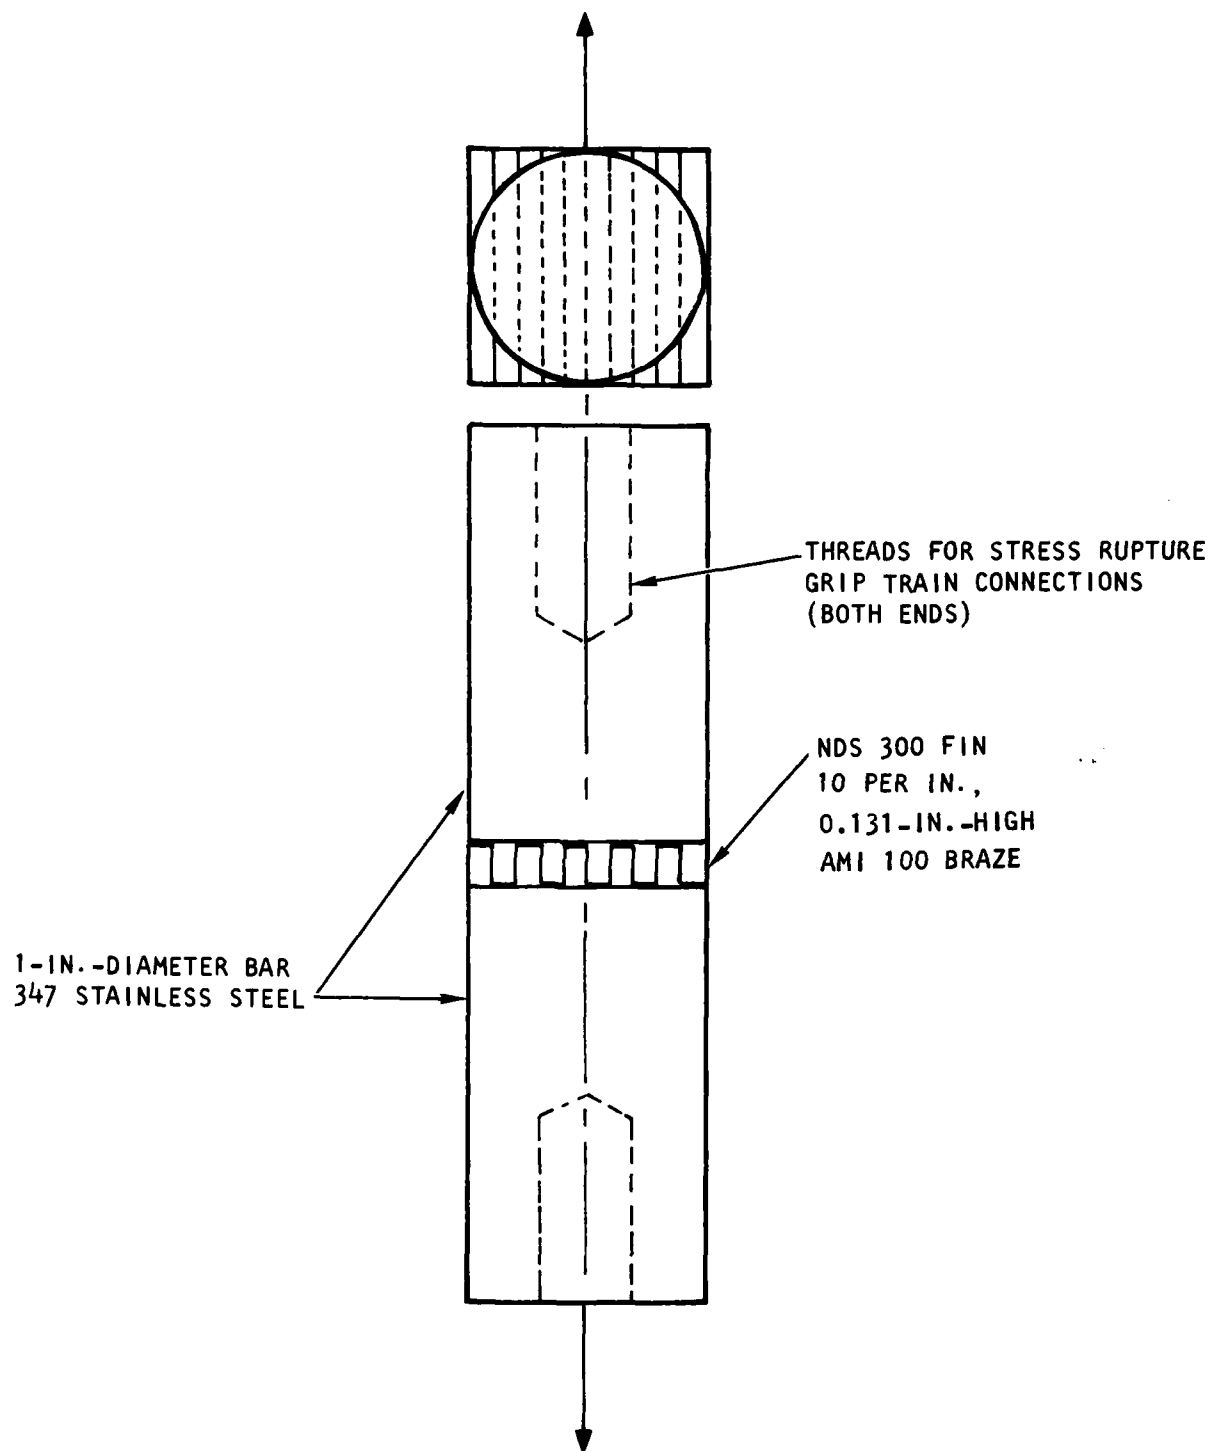
Figure 2-18. Sketch of Brazed Fin-Stud Pull Test Assembly (Not to Scale)
